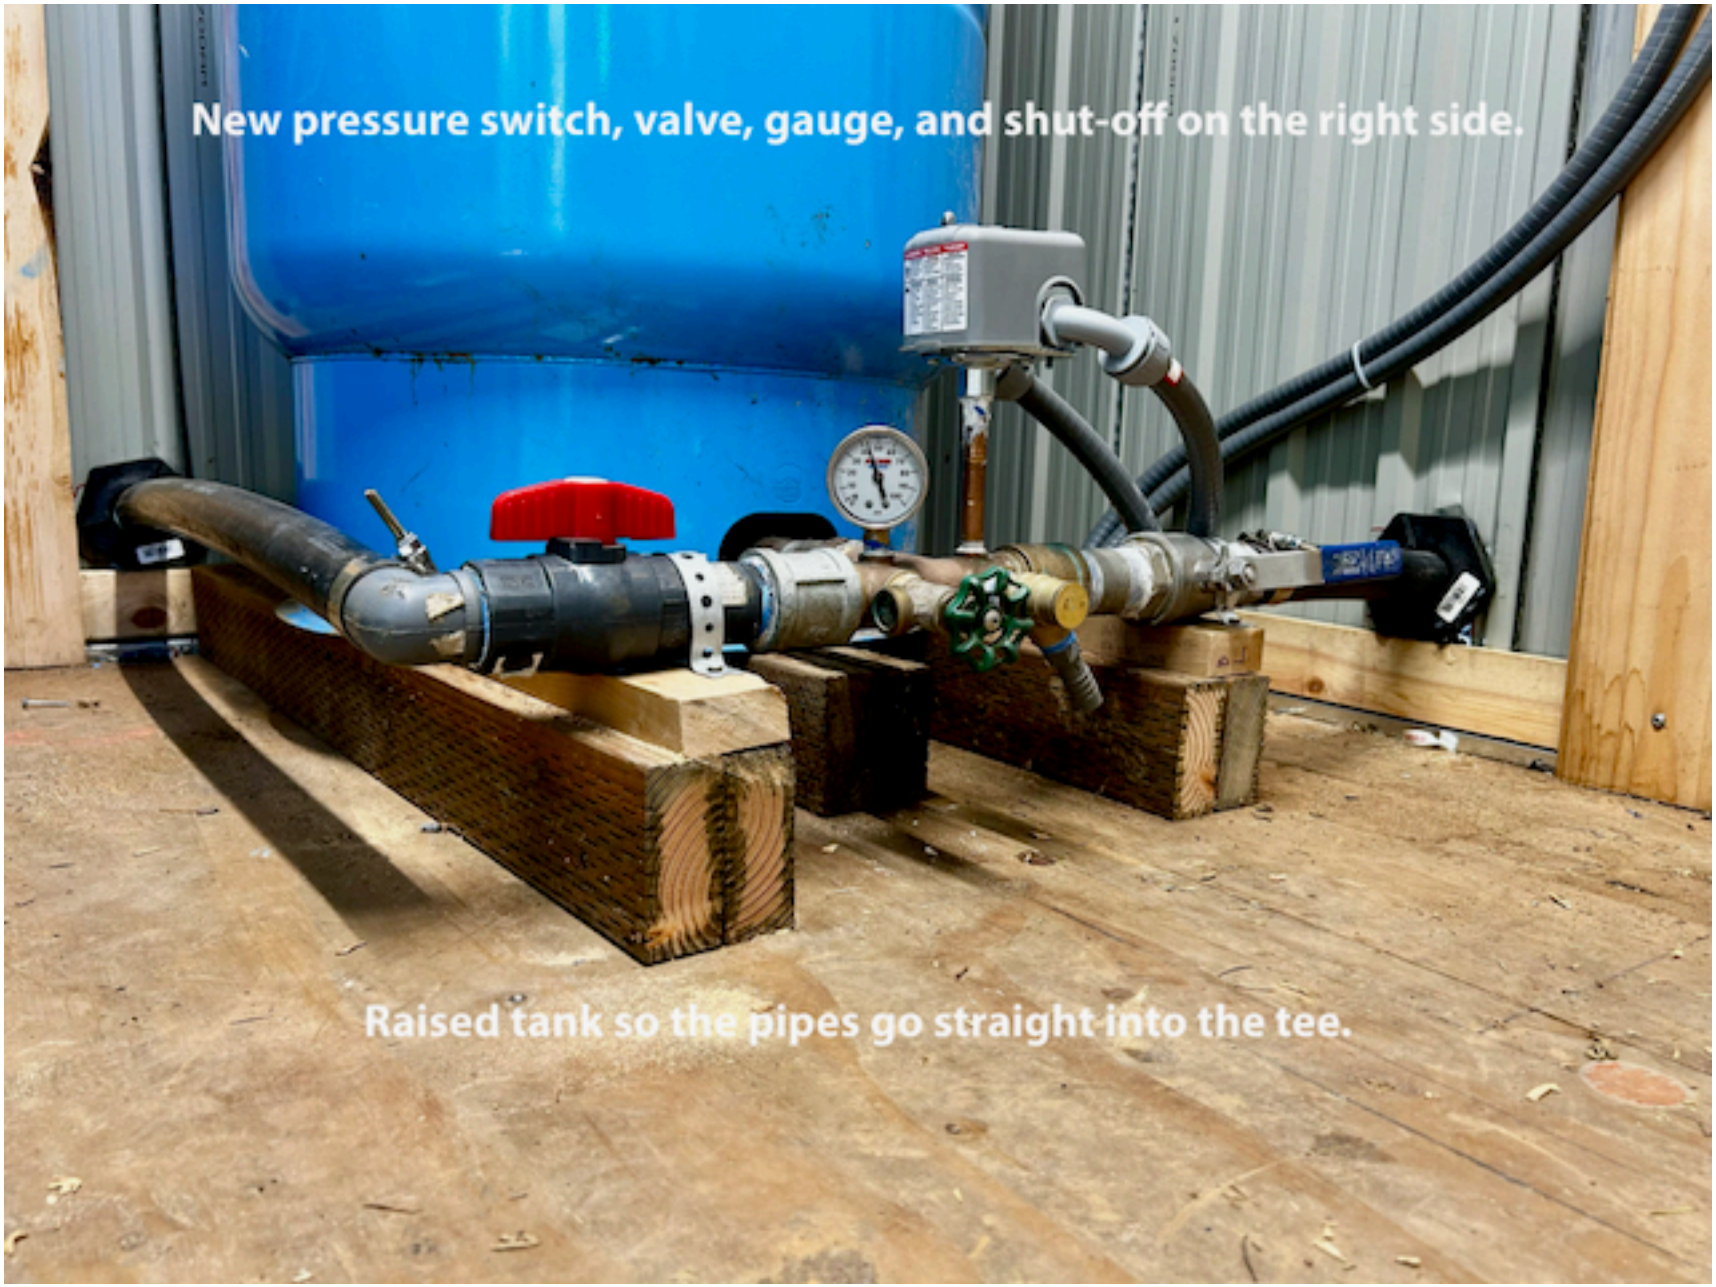
Changed out all the parts that were leaking.
Pressure switch and gauge were not accurate,
and there was no relief valve.
This was about to crack.
replaced with a bronze
fitting.

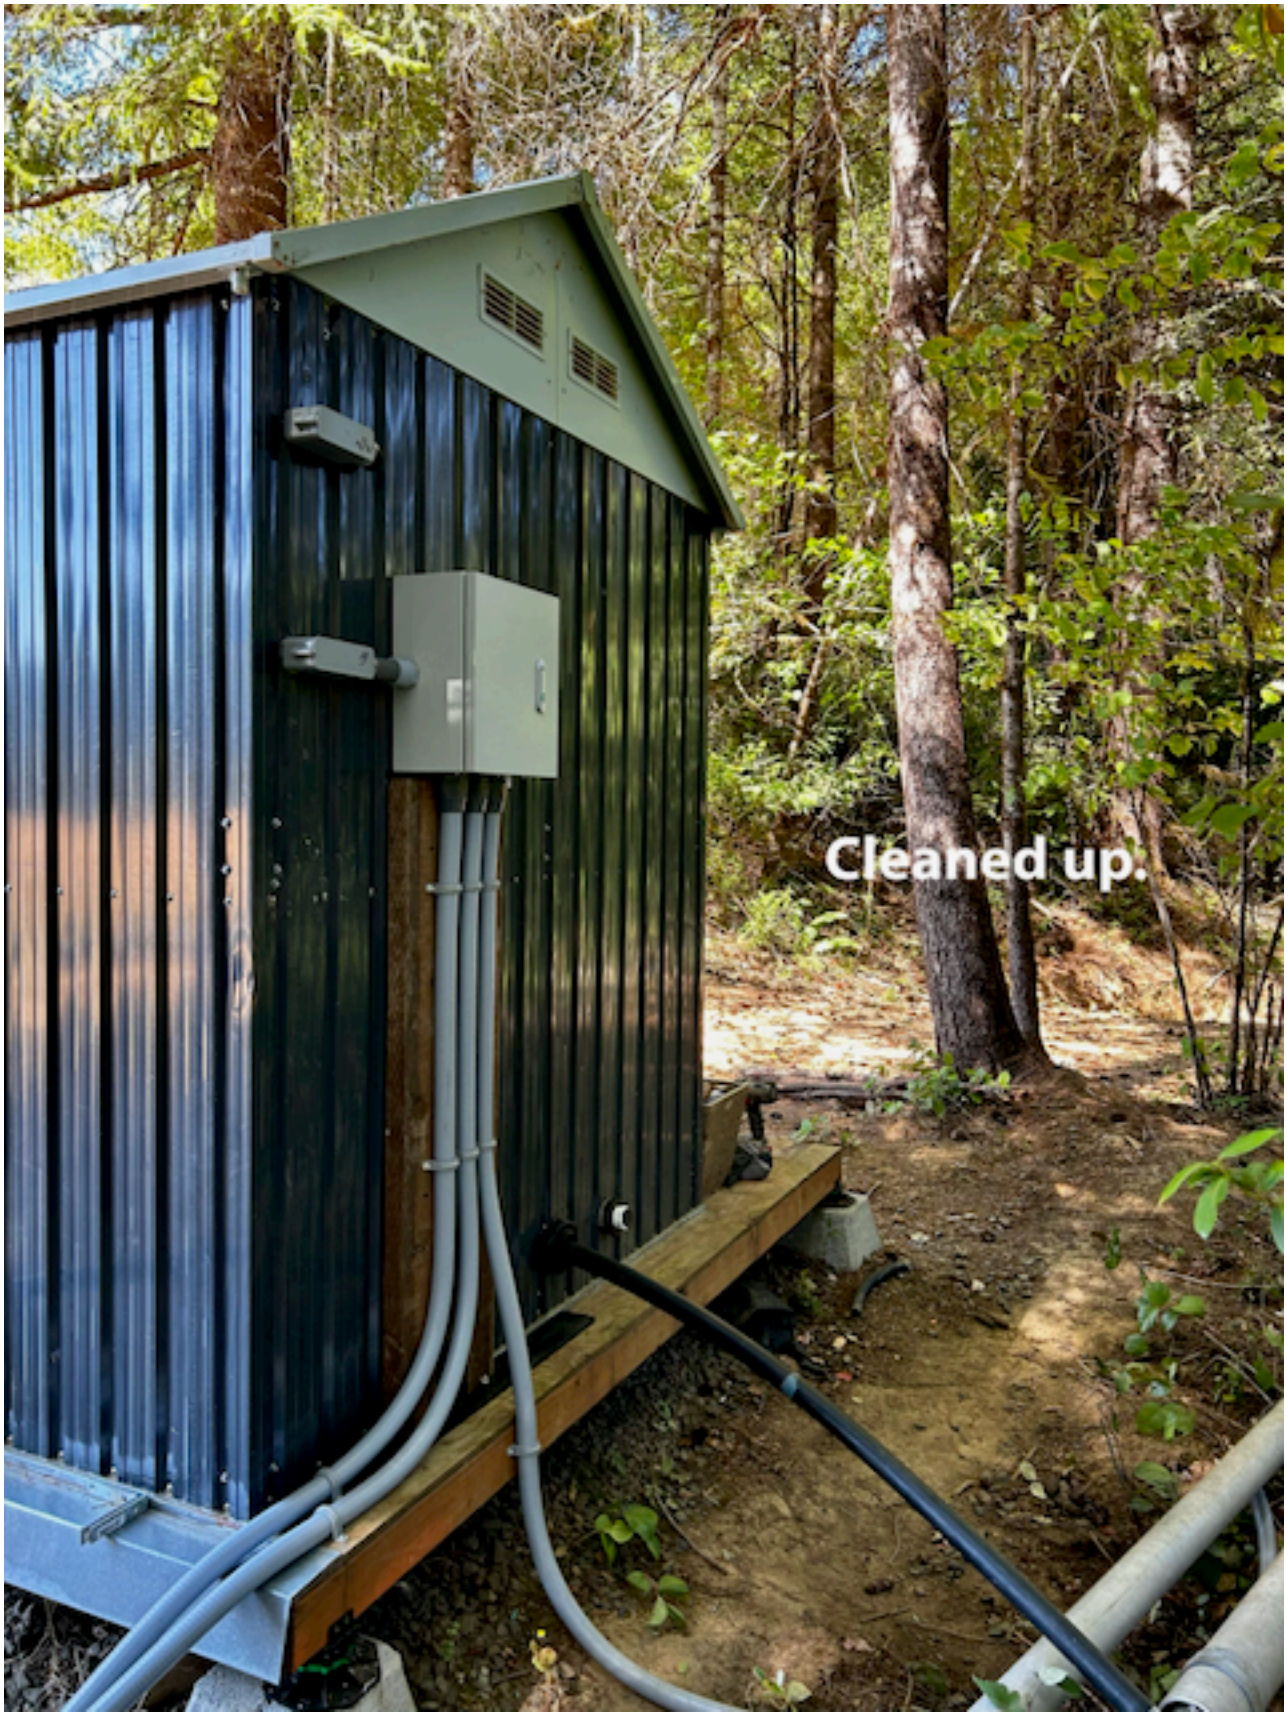
Pump
Pump
This was pretty bad.

New pressure switch, valve, gauge, and shut-off on the right side.
Raised tank so the pipes go straight into the tee.

We made it safer.
